GOVERNMENT OF THE DISTRICT OF COLUMBIA
District Department of the Environment

Illicit Discharge Investigation Report

Case Number: 100330

Location: 1711 1st St., SW (Super Salvage, Inc.)

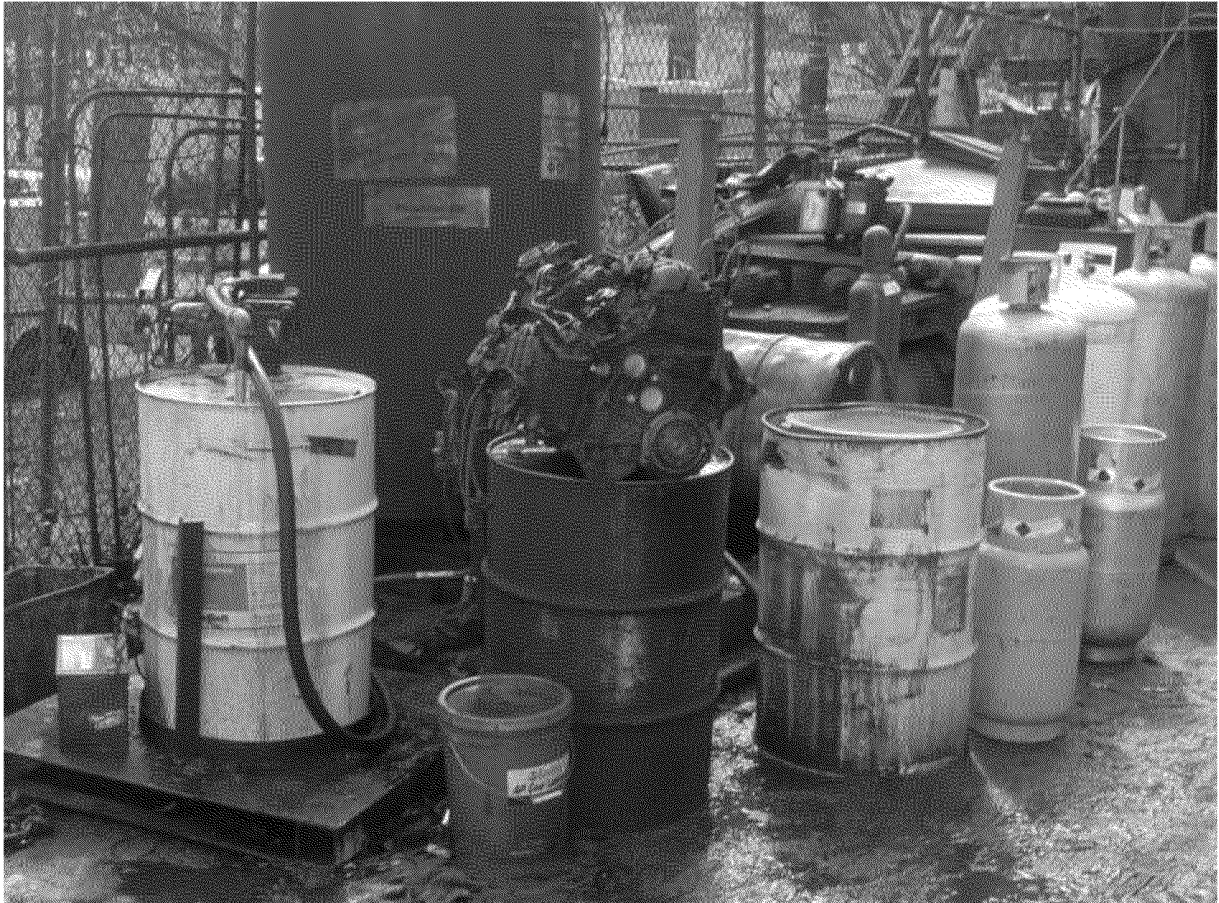
Waste material storage at 1711 1st St., SW

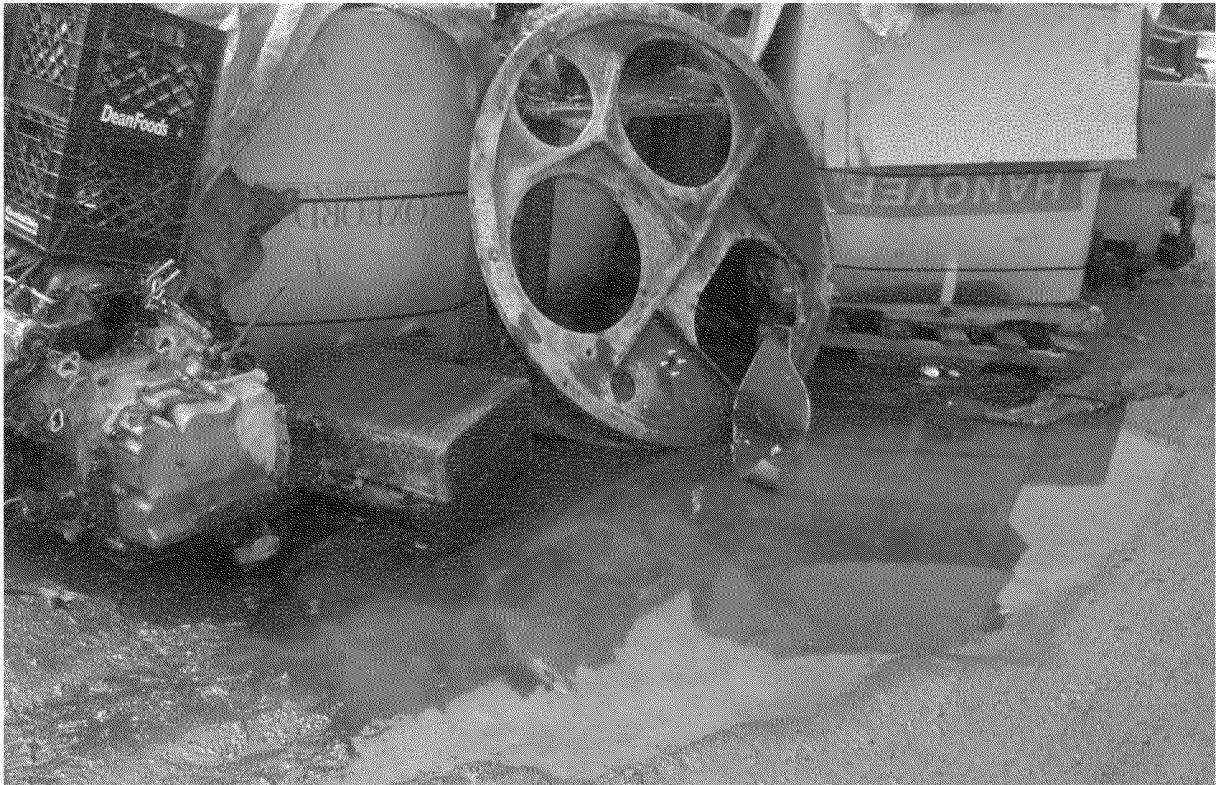
Inspectors noticed various types of fluids leaking from storage boxes left on the grounds of the property, automotive parts, and also from buildings on the property. Upon asking why fluids were coming out of the buildings, inspectors were told that they had a malfunction with the hydraulic equipment the day prior, and they are working on fixing that problem. During the time of inspection, the hydraulic equipment was turned off. Inspectors also noticed what seemed to be a concrete hole in the ground. Mr. Bullock told inspectors it was used for collecting runoff fluids on the property. Mr. Bullock stated that this "runoff collection unit" is later pumped into the pond of the back of the building. An employee on site disagreed with Mr. Bullock and said that contractors came to pump liquids from the concrete hole, and that it was a closed catchment system. When asked to see documentation that such fluids are been picked up, Super Salvage was unable to locate the paper work.

Storage boxes leaking of fluids at 1711 1st St., SW

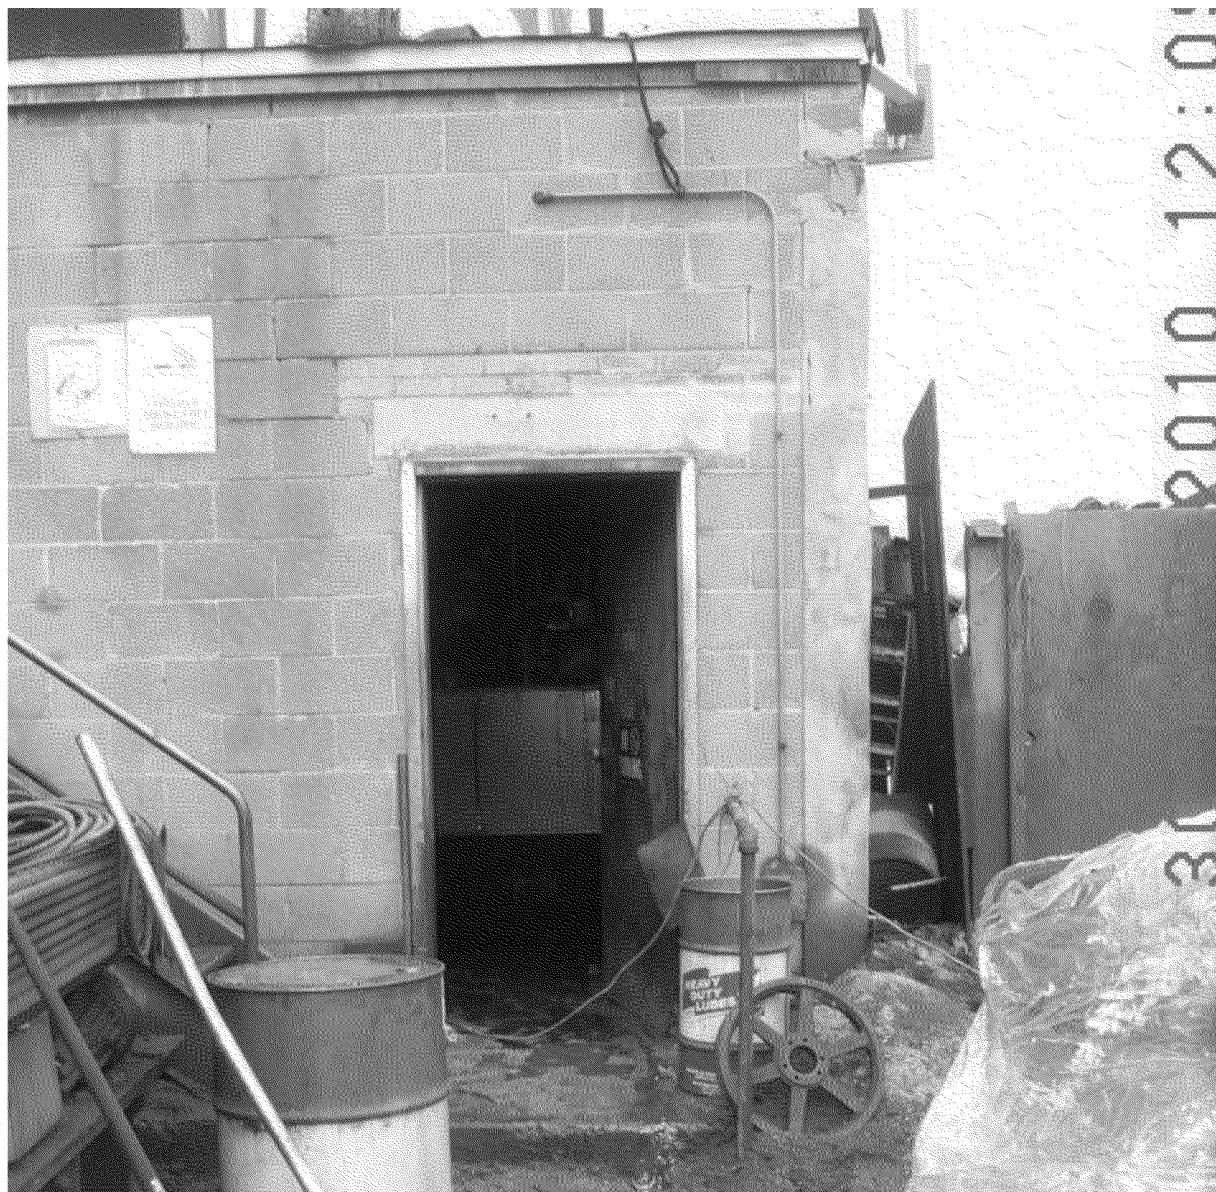
Equipment building with fluids coming out it at 1711 1st St., SW

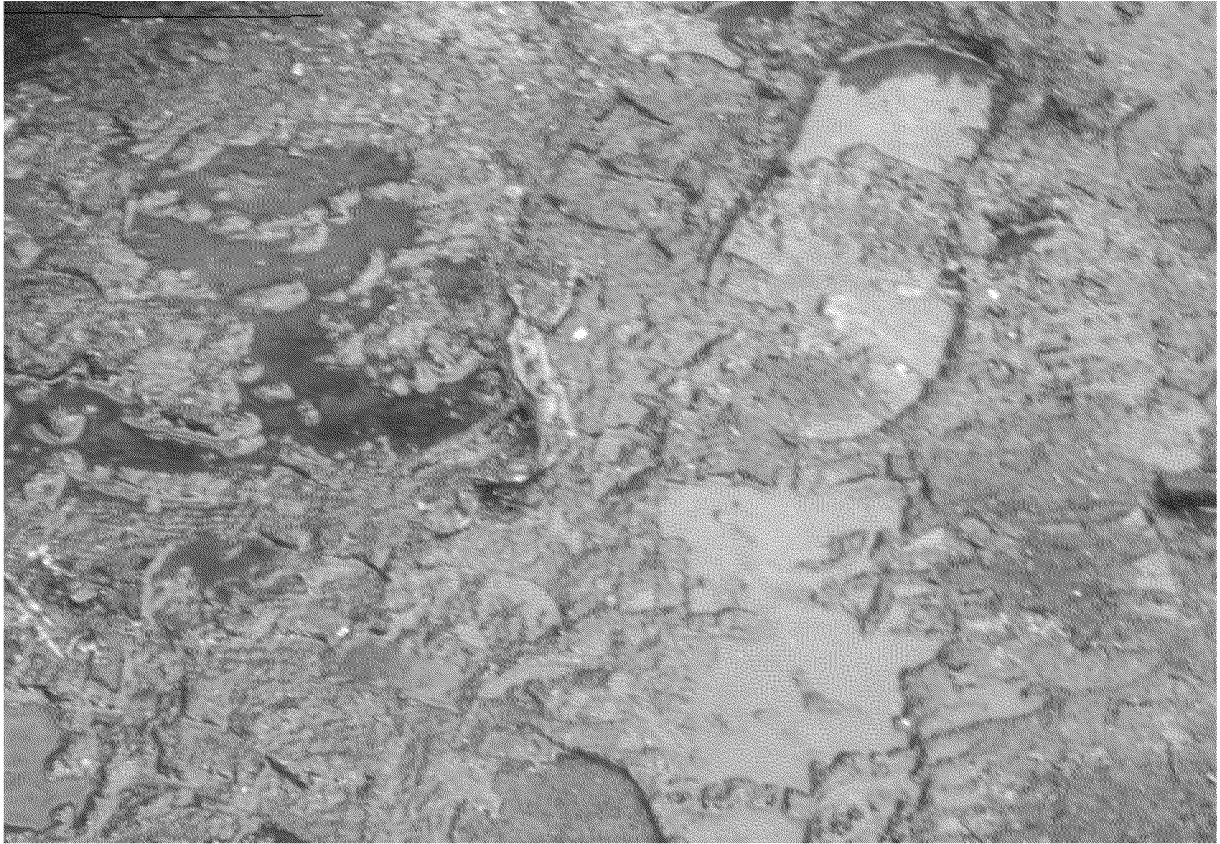
Inspectors also noted a large pond-like structure behind one of the equipment buildings which was filled with a mix of water and various unknown fluids. When asked why such a pond existed, Mr. Bullock stated that for several years they have always pumped such liquids into the hole which they allow to drain into the ground or evaporate. A majority of this property is not paved, and it is also apparent that the operations at this facility have resulted in severe contamination to soil in and around the property.

Contaminated soil area at 1711 1st St., SW

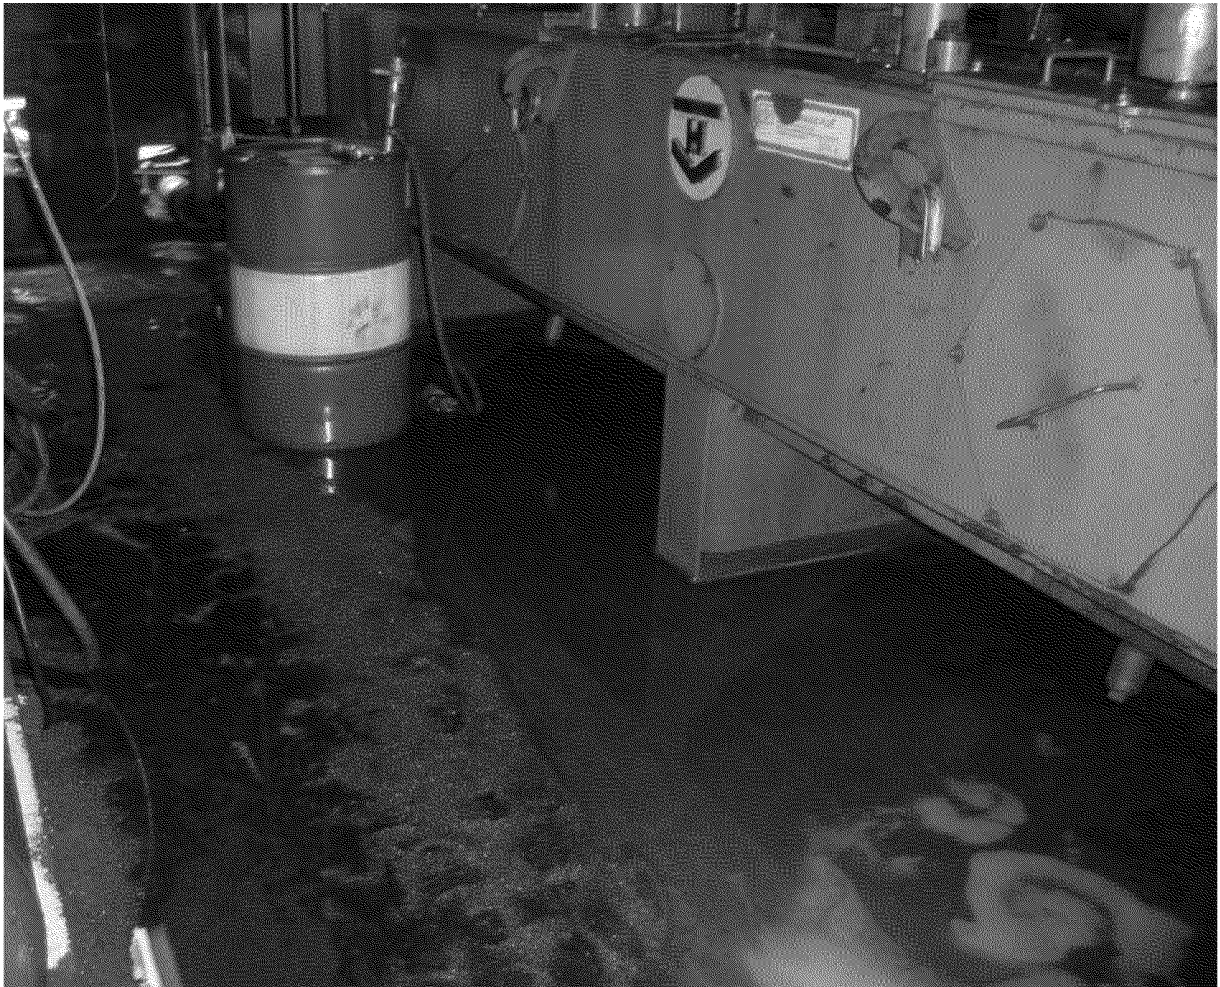
Equipment Building showing fluid on the floor at 1711 1st St., SW

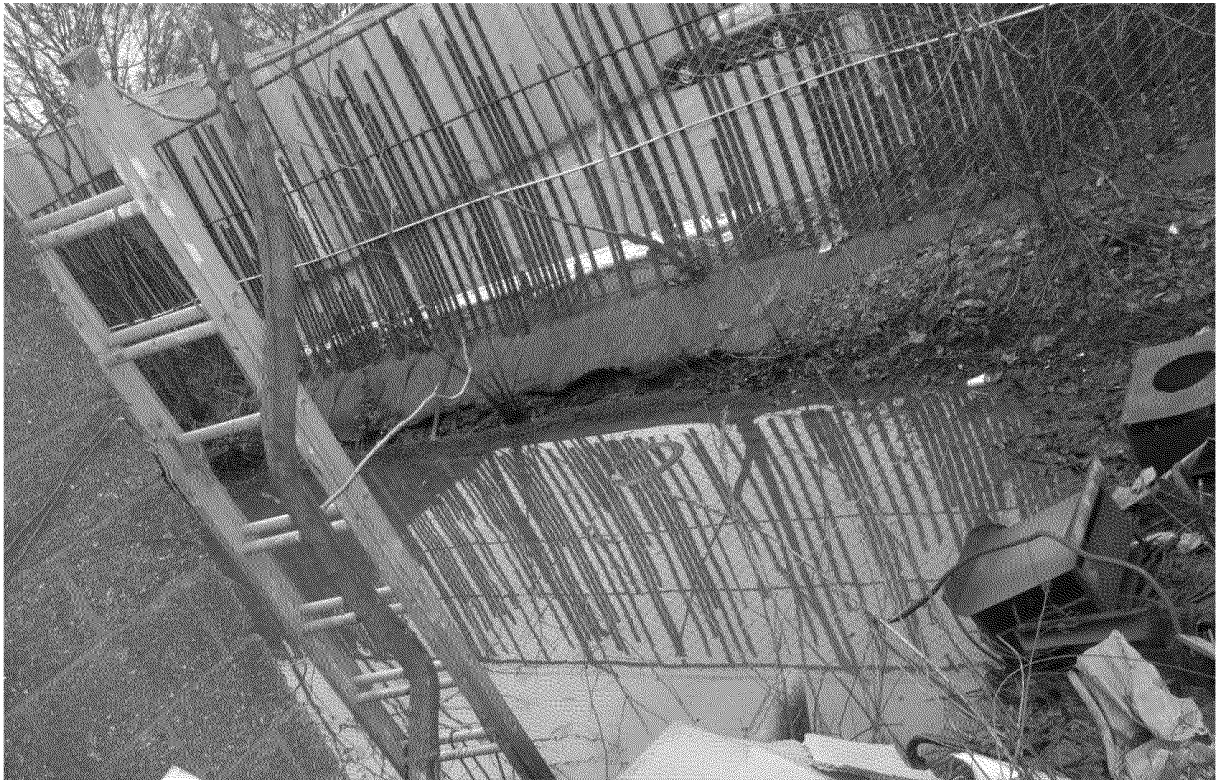
Hole in the ground with different pumped liquids at 1711 1st St., SW

Water Quality Division inspectors are recommending that we have a multi-media inspection that also includes other District and Federal agencies. Directives should be issued to prevent future contaminated runoff from impacting ground or surface water in the District.
